HYUNDAI Technical Service Bulletin	GROUP RECALL	NUMBER 21-01-055H-2
	DATE July, 2021	MODEL(S) Santa Fe (TMa) Sonata (DN8a)
SUBJECT:	HIGH PRESSURE FUEL PIPE INSPECTION AND REPLACEMENT (RECALL 207)

This TSB supersedes TSB# 21-01-055H-1 to revise the high-pressure fuel pump flange nut torque specification listed in pages 5, 8, and 9.

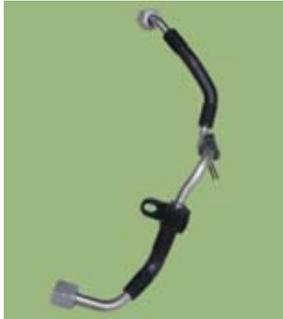
PART NAME	PART NUMBER		FIGURE	NOTES
	OLD	NEW		
High Pressure Fuel Pipe	35305-2S000	35305-2S200QQH

Replace if it does not pass LOT code inspection, or if a leak is found after

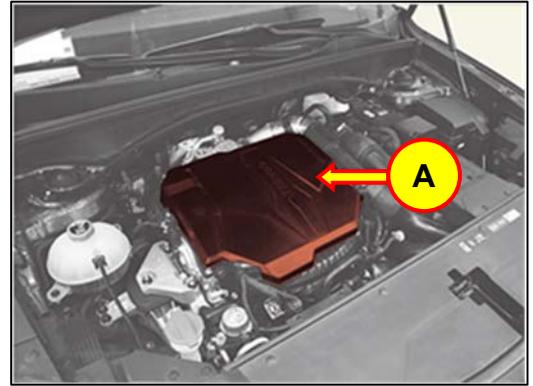
1. Open the hood and remove the engine top cover (A).

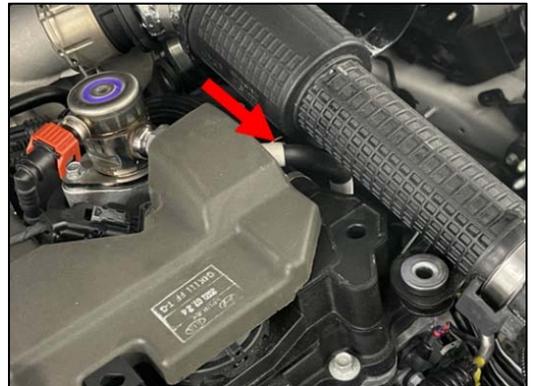
2. Locate the high pressure fuel pipe and pipe insulator (as shown by the red arrow).

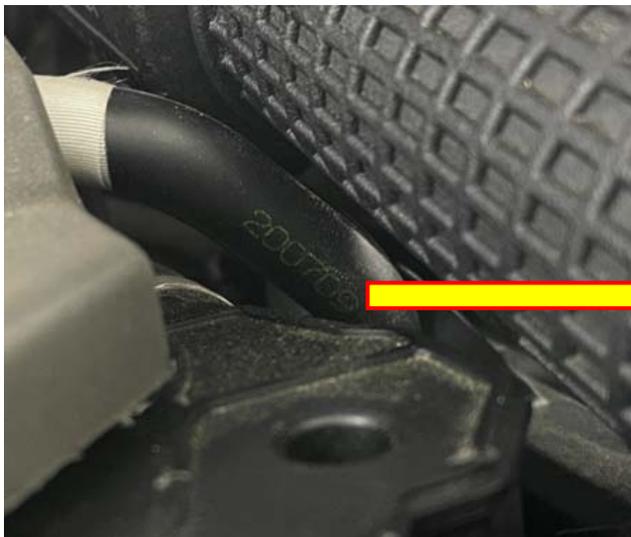
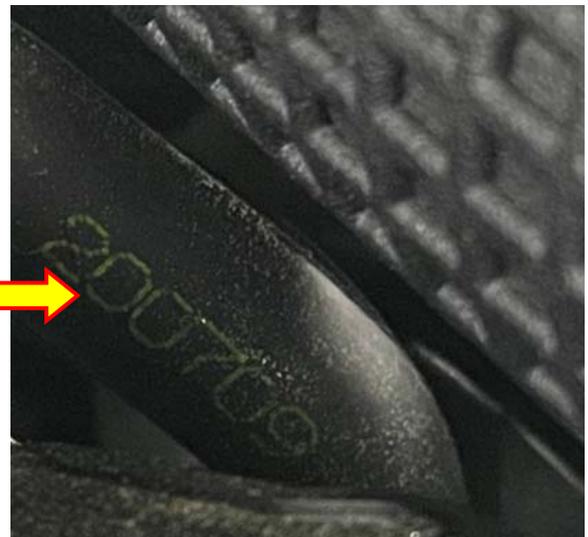
3. On the high-pressure fuel pipe insulator, locate the printed LOT number.

4. Review the LOT number inspection criteria below for the high pressure fuel pipe.
 - If the LOT number is 210111, it is **NG**.
 - Take a picture of the LOT number and replace the high-pressure fuel pipe with the Service Procedure on page 8.
 - If the LOT number is not 210111, it is **OK**.
 - Take a picture of the LOT number proceed to step 5 in the Inspection Procedure.

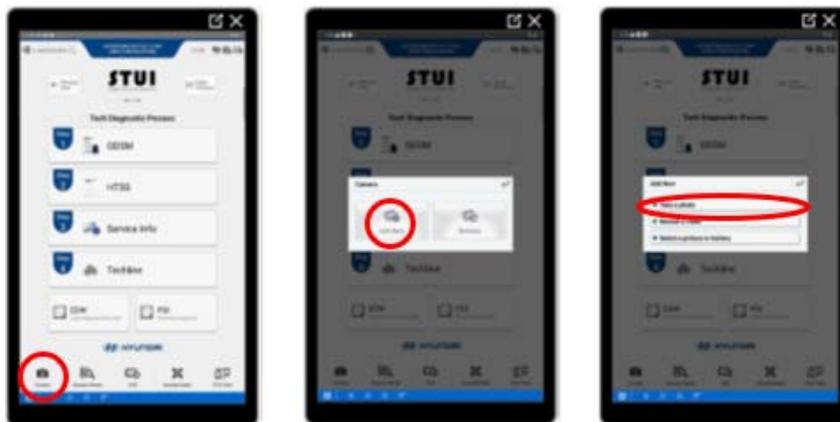
Using STUI, take clear picture(s) of the Lot Number.

Please include the VIN or copy of the RO with the VIN in the STUI picture of the fuel pipe.

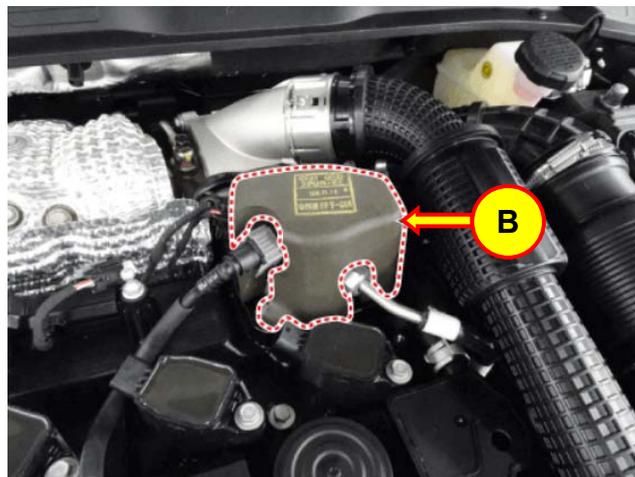
5. Remove the high-pressure fuel pump foam cover (B).

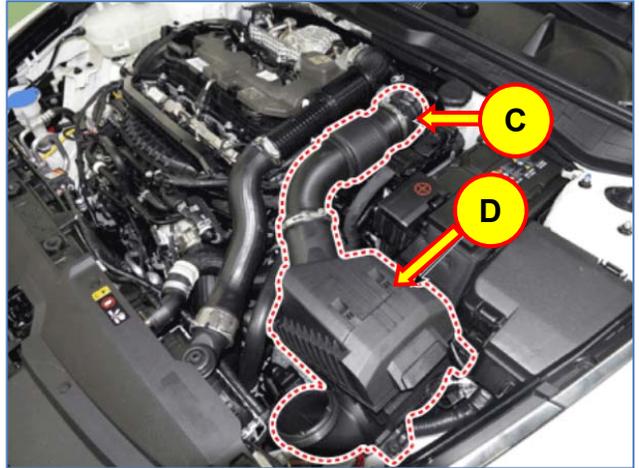
6. Remove the air intake hose (C) and the air cleaner assembly (D).

- Intake hose clamp:
 - 2.9 lb-ft (3.9 Nm)
- Air cleaner mounting bolt:
 - 6.5 lb-ft (8.8 Nm)

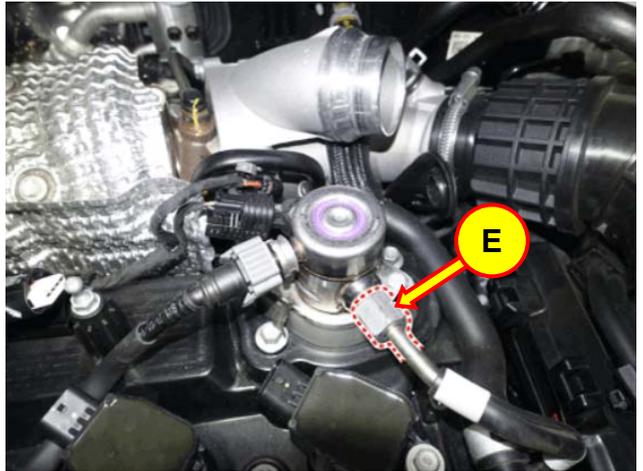
7. Using a torque wrench and SST 09314-3Q100, verify that the high-pressure fuel pump flange nut (E) is torqued to specification.

- 25 lb-ft (34 Nm)

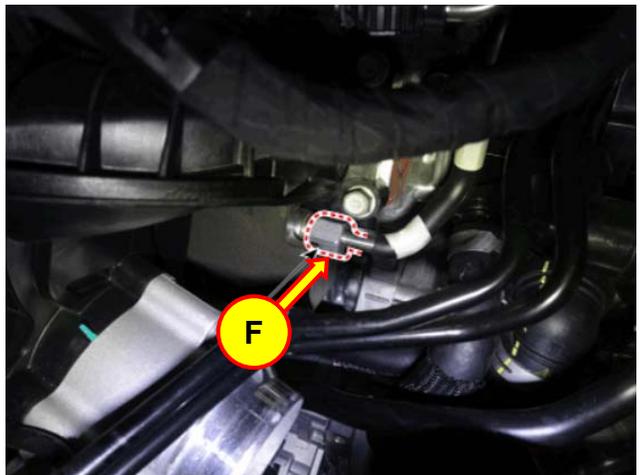
8. Using a torque wrench and SST 09314-3Q100, verify that the high-pressure fuel rail flange nut (F) is torqued to specification.

- 25 lb-ft (34 Nm)

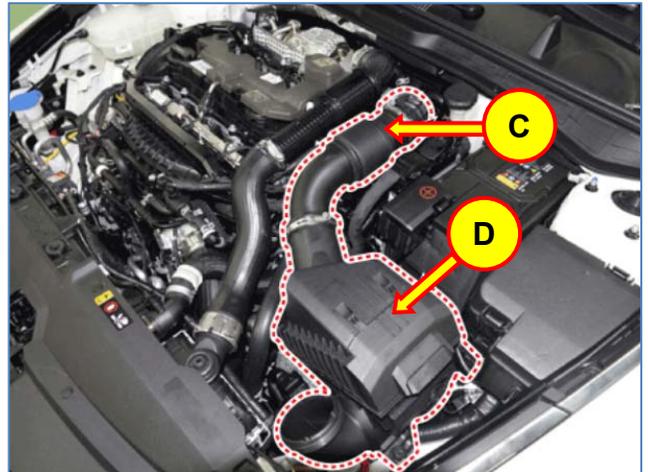
9. Reinstall the air intake hose (C) and the air cleaner assembly (D).

- Intake hose clamp:
 - 2.9 lb-ft (3.9 Nm)
- Air cleaner mounting bolt:
 - 6.5 lb-ft (8.8 Nm)

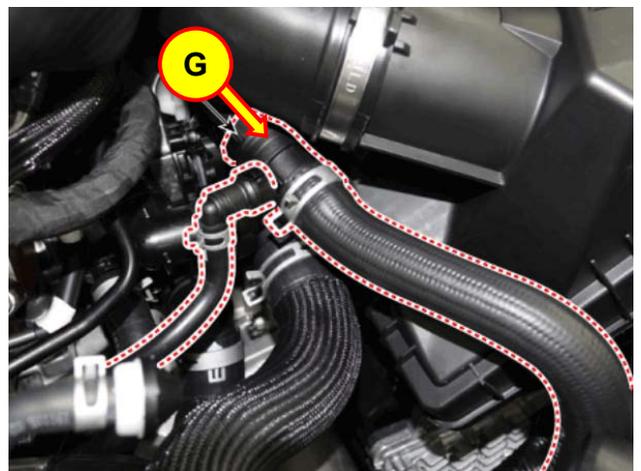
11. Turn the ignition switch OFF and disconnect the RCV hose (G) to begin air cleaner removal.

Removing the air cleaner is necessary to properly inspect for leaks using the oil test paper.

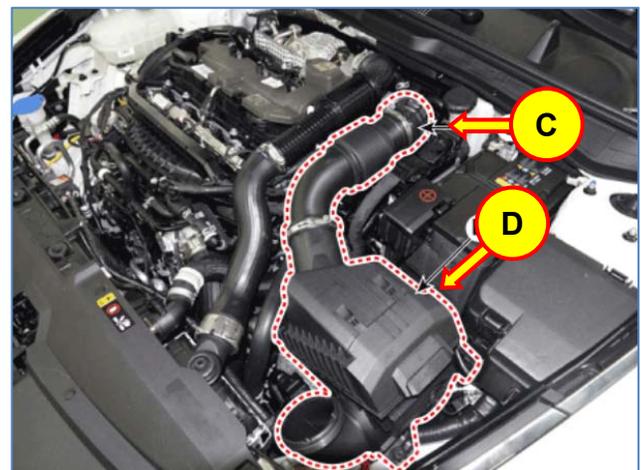
12. Disconnect the air intake hose (C).

If extra working room is needed, remove the air cleaner assembly (D).

- Intake hose clamp:
 - 2.9 lb-ft (3.9 Nm)
- Air cleaner mounting bolt:
 - 6.5 lb-ft (8.8 Nm)

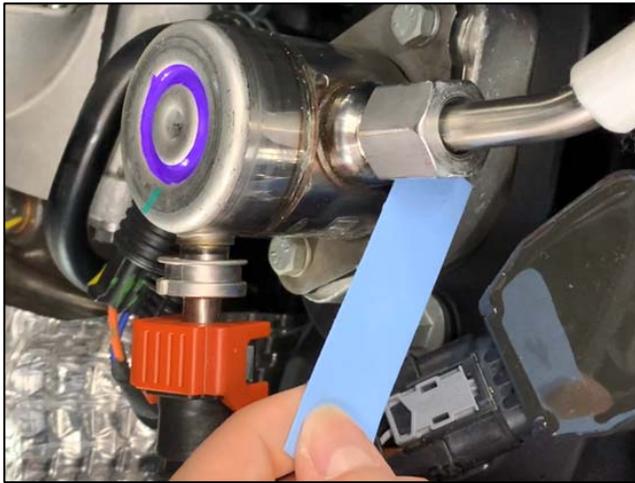
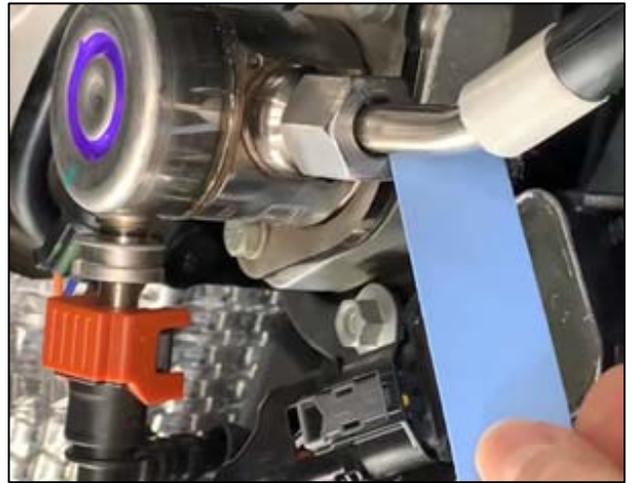
13. Inspect before and after the high pressure fuel pump flange for leakage using an oil test paper.

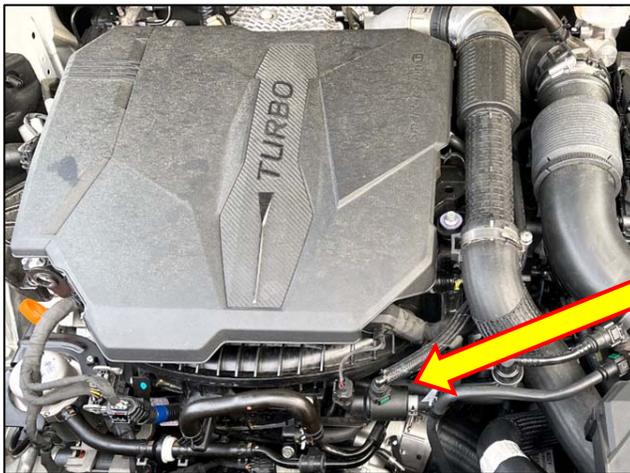
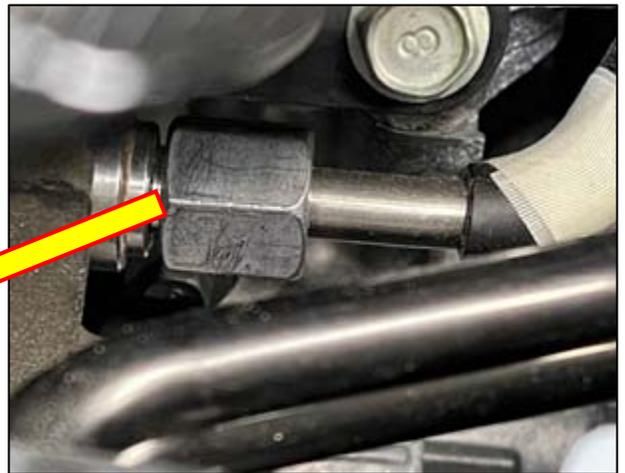
14. Inspect before and after the high pressure fuel rail flange for leakage. Use the other side of the oil test paper if necessary.

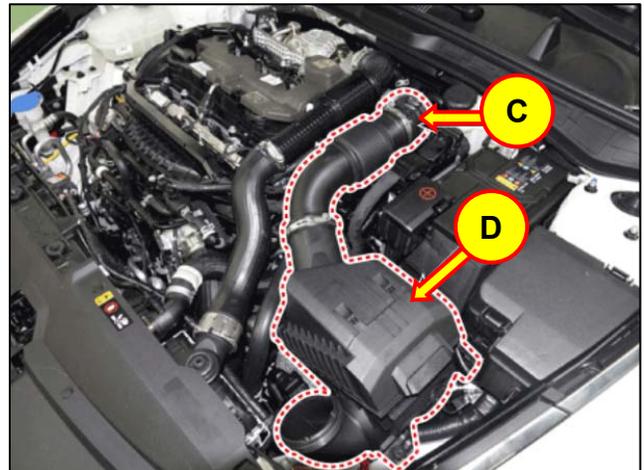
3. If not already removed, disconnect the air intake hose (C).

If extra working room is needed, remove the air cleaner assembly (D).

- Intake hose clamp:
 - 2.9 lb-ft (3.9 Nm)
- Air cleaner mounting bolt:
 - 6.5 lb-ft (8.8 Nm)

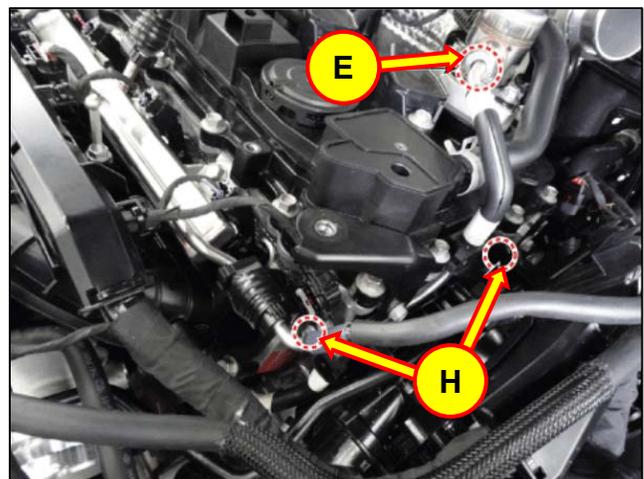
4. Remove the high pressure pipe bracket bolts (H) and fuel pump flange nut (E).

Remove high pressure fuel pump flange nut with SST 09314-3Q100.

- High pressure pipe bracket bolts:
 - 7.95 lb-ft (10.8 Nm)
- High pressure pump flange nut:
 - **25 lb-ft (34 Nm)**

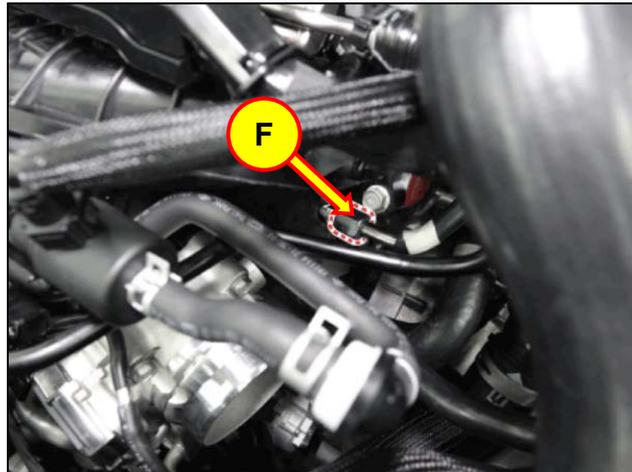
5. Remove the high pressure fuel rail flange nut (F) with SST 09314-3Q100.

- 25 lb-ft (34 Nm)
